Bike-ability Assessment

Bellevue College

Date/Time: Tuesday, May 13, 2014, 4-5:30pm

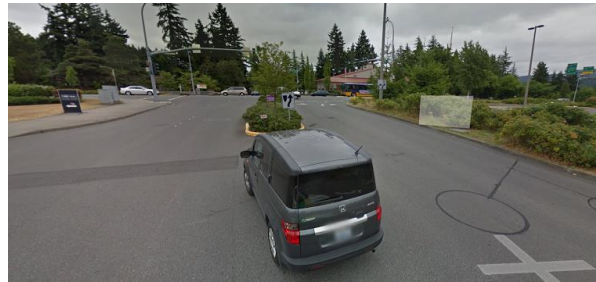
Area: BC Parking Bus Shelter through Campus Entrance/Exit at 148th Ave SE

- Tyee River Rd. on campus is mostly safe and comfortable for bicyclists.
- Landerholm has 2 right-turn lanes and a left turn lane at the approach to 148th Ave SE. To cross 148th, bicyclists must take center-turn lane to cross on the sidewalk on the left side of the street. This can be challenging when there are high volumes of traffic passing through.
- Bicyclists must use signalized pedestrian crosswalk to cross 148th. Motor vehicle lanes only have right turn lanes. (crosswalk on other side?? check)
- Bicyclists can also use an alternative route (as mapped above) by taking a left on 145th and then a quick right through the parking lot up to the intersection of 28th and 148th.

- Bicycle wayfinding on Tyee River Rd.
- Wayfinding directing cyclists to use the center-turn to reach the crosswalk. Clear signage instructing bicyclists to use crosswalk (i.e. green signs or street paint with cross bikes).
- Although the bikeability assessment took the alternative route through the parking lot, wayfinding on Landerholm and 148th St. would provide bicyclists with a convenient and intuitive route entering and exiting campus.

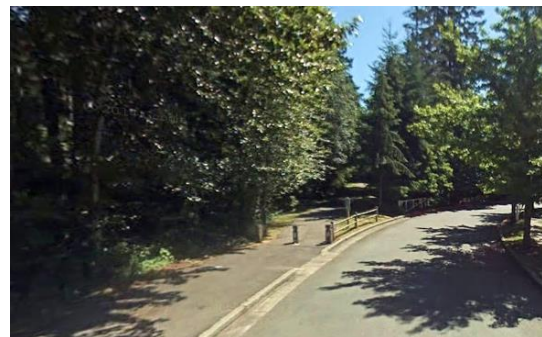
Area: SE 28th st. along paved Robinswood bike trail (Robinswood Park is on the left) to exit at Microsoft parking lot.

- SE 28th St. is a low-trafficked paved street leading to Church and parking lots.
- Paved trail starts on sidewalk. Several curb cuts allows bicyclists to easily ride onto sidewalk.
- Paved trail is dark and wooded.
- The crossing at 156th Ave SE uses a rectangular rapid flash beacon. Bicyclists can use cross walk.
- Trail turns into gravel path east of 156th Ave SE. There is a desired path bicyclists use that cuts that connect from the Robinswood trail through the Microsoft parking lot.

- Clear wayfinding directing for bicyclists to trail at end of SE 28th (see image to the right). While there is wayfinding directed toward pedestrians, they are hard for bicyclists to see (insert picture from NACTO here).
- Lights on paved trail and gravel trail as this section can be very dark at night or on rainy days.
- Wayfinding at trail cut-off into Microsoft parking lot (if possible to coordinate with Microsoft).

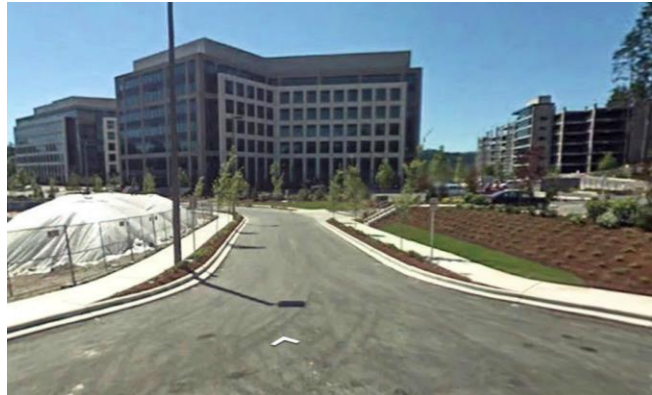
Area: Trail cut-off at Microsoft parking lot to Access Rd. (which turns into SE 30th Pl), right on 160th St. to intersection at SE Eastgate Way.

- Access Rd. (see image to the right) felt safe and comfortable for cyclists at 4:30pm when there wasn't any traffic. This could feel different during commuting hours when Microsoft employees are driving in and out of parking lots.
- Right turn onto 160th feels comfortable.

- Wayfinding directing bicyclists through this somewhat confusing cut-off from the off-street trail through Access Rd. to 160th St.

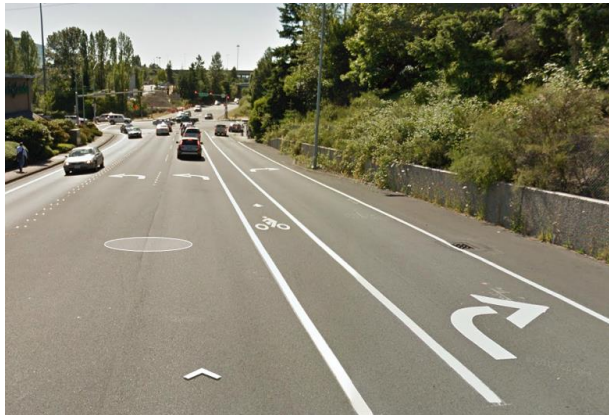
Area: Intersection of 1-90 Trail and Factoria Blvd SE

- The approach to this intersection is tricky for bicyclists who ride down the long hill on 36th in the shoulder bike lane and must then merge left into a bike lane between the right turn lane and left turn lane.

- Bicyclists do not have a clear wayfinding through the intersection to reach the 1-90 trail across the street. There is no clear lane positioning through the intersection for bikes.
- Vehicles do not consistently yield to bikes in the crosswalk or crossing with the light in this intersection.

- Painted yellow ramps onto the sidewalk are

designed to be used with the crosswalks, not positioned easily for cyclists crossing the intersection. Cyclists entering the sidewalk may be cut off by cars waiting to turn right.

- Green paint on this bicycle lane leading to the intersection could make the lane more visible to motorists.
- Cross bike paint through the intersection may help bicyclists feel safer and more comfortable and increase motorist and bicyclist predictability.
- No right turn on red or motorists yield to bikes and peds in crosswalk (picture of this kind of sign)
- Wider ramp entrance onto the sidewalk for cyclists.

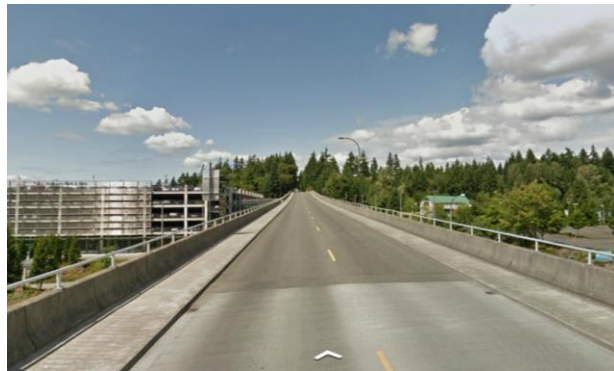
Area: 142nd St. (between 36th St. and Bellevue College)

- During the bikeability assessment, riders rode up 36th on the shoulder bike lane and used the crosswalk at 142nd St. to make the left turn onto 142nd.
- There is, however, a left-turn lane for cars at this intersection.
- 142nd St. has two key destinations for bicyclists: the Eastgate Park & Ride and the back entrance to Bellevue College.
- There is not a bike lane on 142nd St. There is a sidewalk, but no shoulder on the road (see image).

- Bicycle treatments at the intersection of 36th and 142nd (either pavement markings in the left-turn lane or “cross bike” paint or signage at the pedestrian crosswalk).
- Bicycle wayfinding for the Eastgate Park & Ride and Bellevue College at the 36th/142nd intersection.
- A bike lane on 142nd St. would create safer riding conditions for bicyclists who are trying to reach the Eastgate Park & Ride or Bellevue College.
